Manhole Inspection Summary

Manhole # S43E__033MH

Location Address: **Broadway**

Cross Street: **Bethel St**

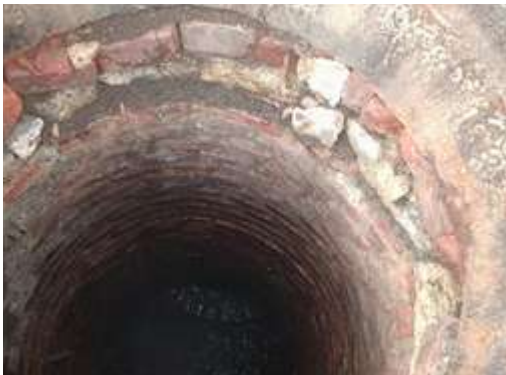
Defect 2

Condition: ☐ Sound ☒ **Cracked** ☐ Root Intrusion ☒ **Loose Brick** ☒ **Deteriorated**

Loose Bricks

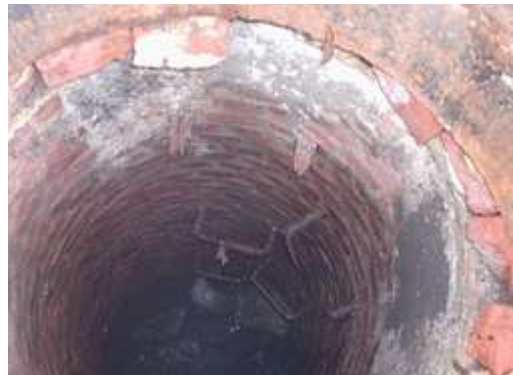
Defect 1

Infiltration: ☐ None ☒ **Joint** ☐ Cracks ☒ **Mortar** ☐ Roots ☐ Wall

Deterioration

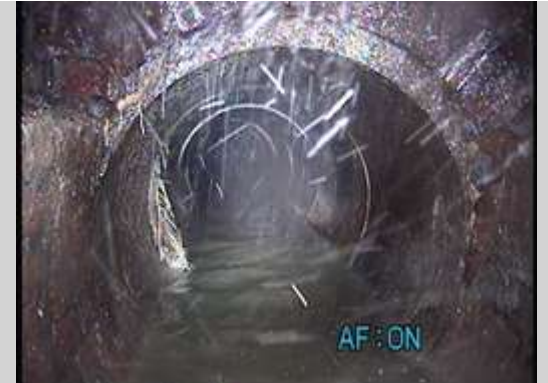
12 O'Clock Outflow

24 in. Circular Gravity Sewer
Pipe Out @ 12 O'Clock

Pipe Height: **24** (in.) Rod and Bar (Angled)
Pipe Material: **Clay** ☐ Pipe Lined
Invert Depth: **19.30** (ft.) Flow Characteristics: **Fast**
Deposits: ☒ None ☐ Mud ☐ Sludge ☐ Debris ☐ Grease
Silt Depth: (in.) Deposits Extent:
Infiltration: **None** Pipe Seal Cond: **Sound**

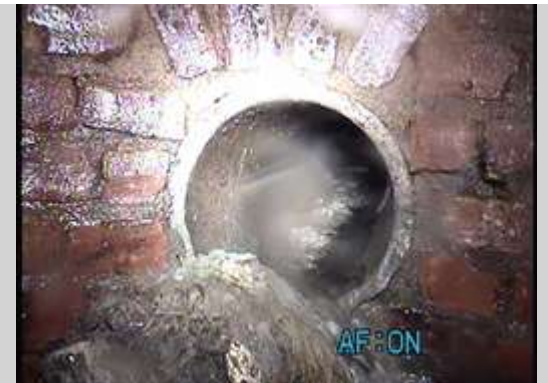
3 O'Clock Inflow

8 in. Circular Gravity Sewer
Pipe In @ 3 O'Clock

Pipe Height: **8.4** (in.) Rod and Bar (Angled)
Pipe Material: **Clay** ☐ Pipe Lined
Invert Depth: **18.80** (ft.) Flow Characteristics: **Slow**
Deposits: ☒ None ☐ Mud ☐ Sludge ☐ Debris ☐ Grease
Silt Depth: (in.) Deposits Extent:
Infiltration: **None** Pipe Seal Cond: **Sound**

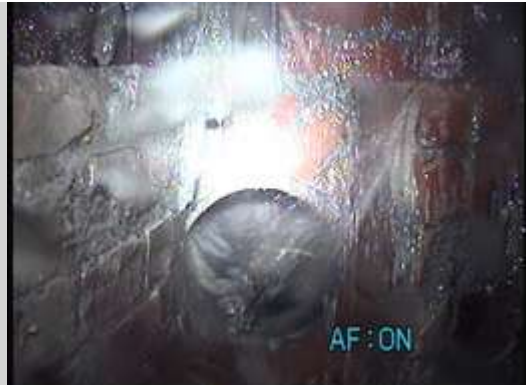
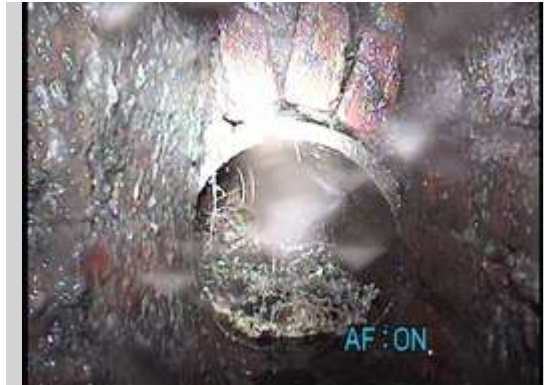
5 O'Clock Inflow

Drop In @ 5 O'Clock

Pipe Height: **8.4** (in.) Rod and Bar (Angled)

Infiltration: **None** Pipe Seal Cond: **Sound**

Drop: Inside	Rod and Bar
Angled: Yes	Reading: 17.85 (ft.)
	Inv Depth: 18.85 (ft.)
Drop Condition: Open

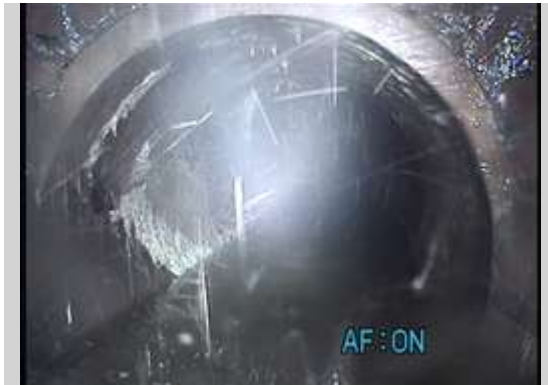
7 O'Clock Inflow

Pipe In @ 7 O'Clock

Pipe Height: **21.6** (in.) Rod and Bar (Angled)

Infiltration: **None** Pipe Seal Cond: **Sound**
